Why Indeed Did the WTC Buildings Completely Collapse?

By Dr. Steven E. Jones

ABSTRACT

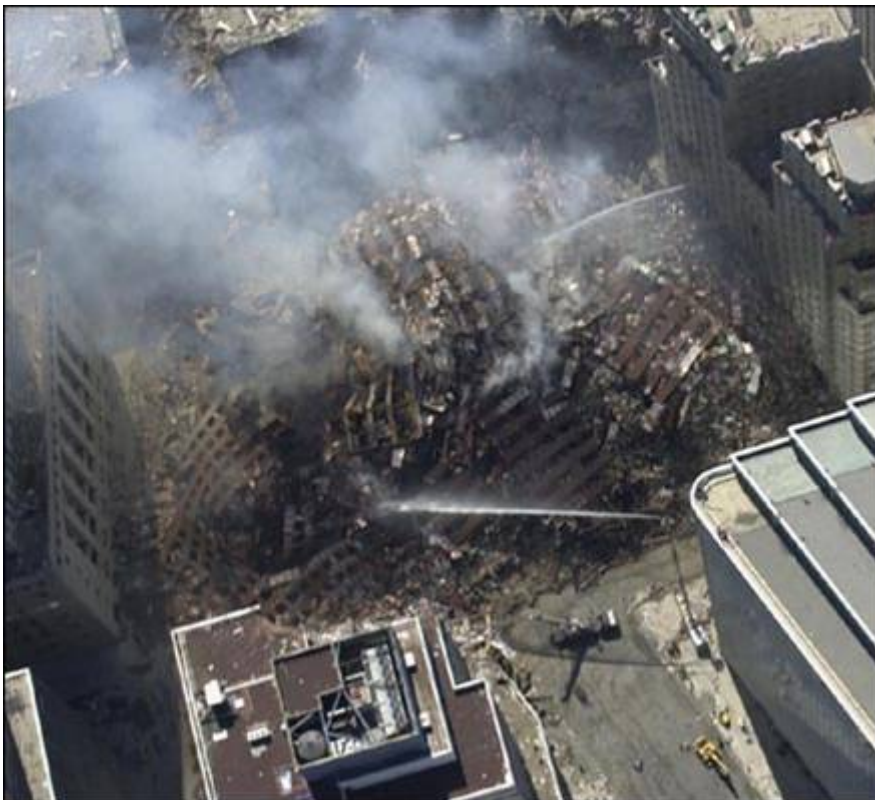
WTC 7 collapsed completely, onto its own footprint

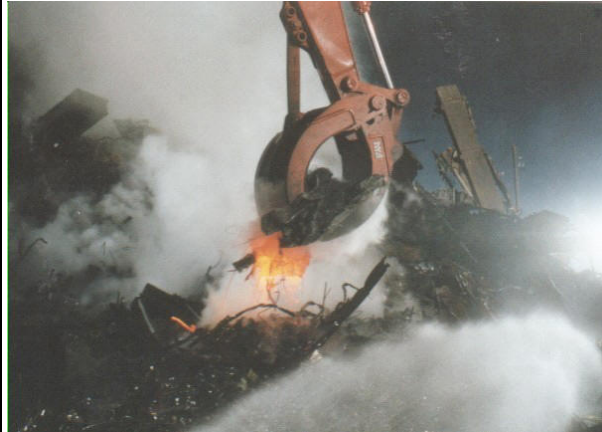
Even without a direct elemental analysis, we can rule out some metals based on available data. The photograph in the introduction shows a chunk of hot metal being extracted at ground zero. The hottest portion of the chunk is the lower portion, which was deepest down in the slag, and the metal is seen to be yellow-hot, certainly above cherry-red hot. The following table (see <http://www.processassociates.com/process/heat/metcolor.htm>) provides data regarding the melting temperatures of lead, aluminum, structural steel and iron, along with approximate metal temperatures by color. Note that the approximate temperature of a hot metal is given by its color, quite independent of the composition of the metal. (A notable exception is falling liquid aluminum, which due to low emissivity and high reflectivity appears silvery-gray in daylight conditions, after falling through air 1-2 meters, regardless of the temperature at which the poured-out aluminum left the vessel. Aluminum does incandesce (glow) like other metals, but faintly, so that with the conditions described in the previous sentence (which prevailed at the WTC on 9/11), falling liquid aluminum will appear silvery-gray. Rapid oxidation of the hot flowing aluminum will contribute to the observed appearance. [Experiments: Jones, 2006])

We see from the photograph above that solid metal from the WTC rubble existed at salmon-to-yellow-hot temperature (approx. 1550 - 1900 °F, 845 - 1040 °C.) The temperature is well above the melting temperatures of lead, zinc and aluminum, and these metals can evidently be ruled out since they would be runny liquids at much lower (cherry-red or below) temperatures. However, the observed hot specimen could be structural steel (from the building) or iron (from a thermite reaction) or a combination of the two. Additional photographs of the hot metal could provide further information and advance the research.

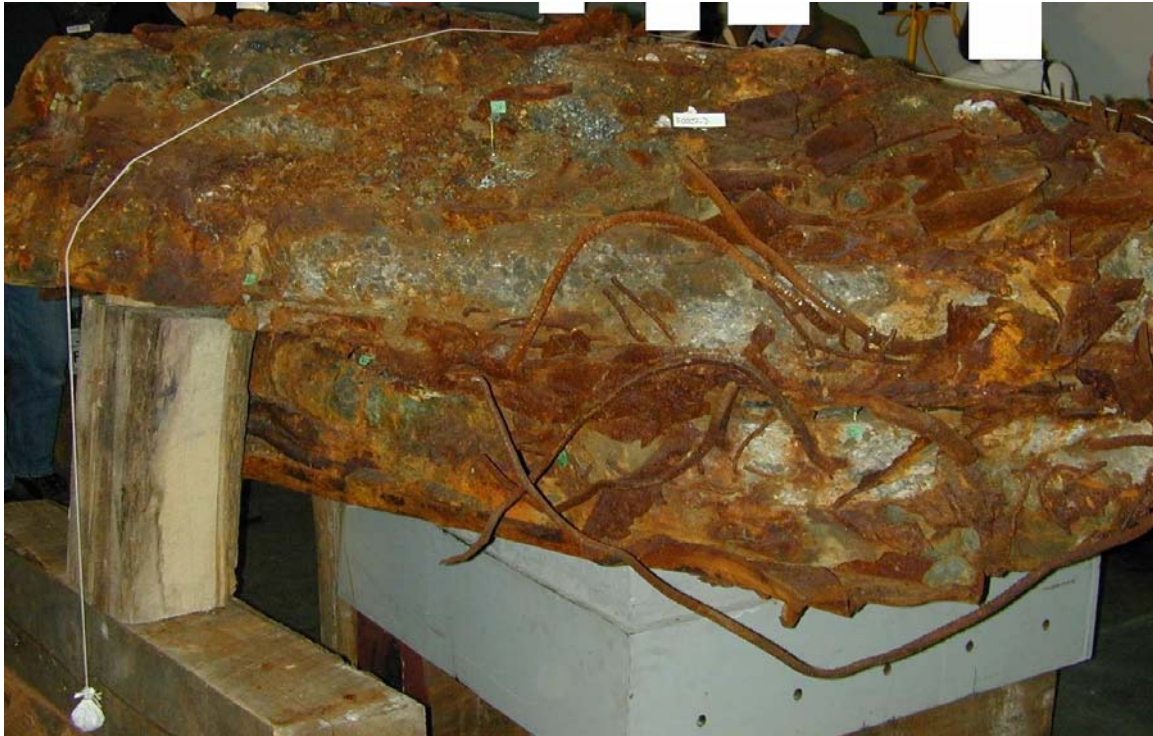
The following photograph has become available, evidently showing the now-solidified metal with entrained material, stored (as of November 2005) in a warehouse in New York:

The abundance of iron (as opposed to aluminum) in this material is indicated by the reddish rust observed. When a sample is obtained, a range of characterization techniques will quickly give us information we seek. X-ray energy dispersive spectrometry (XEDS) will yield the elemental composition, and electron energy-loss spectroscopy will tell us the elements found in very small amounts that were undetectable with XEDS. Electron-backscattered diffraction in the scanning electron microscope will give us phase information; the formation of certain precipitates can tell us a minimum temperature the melt must have reached. We will endeavor to obtain and publish these data, whatever they reveal.

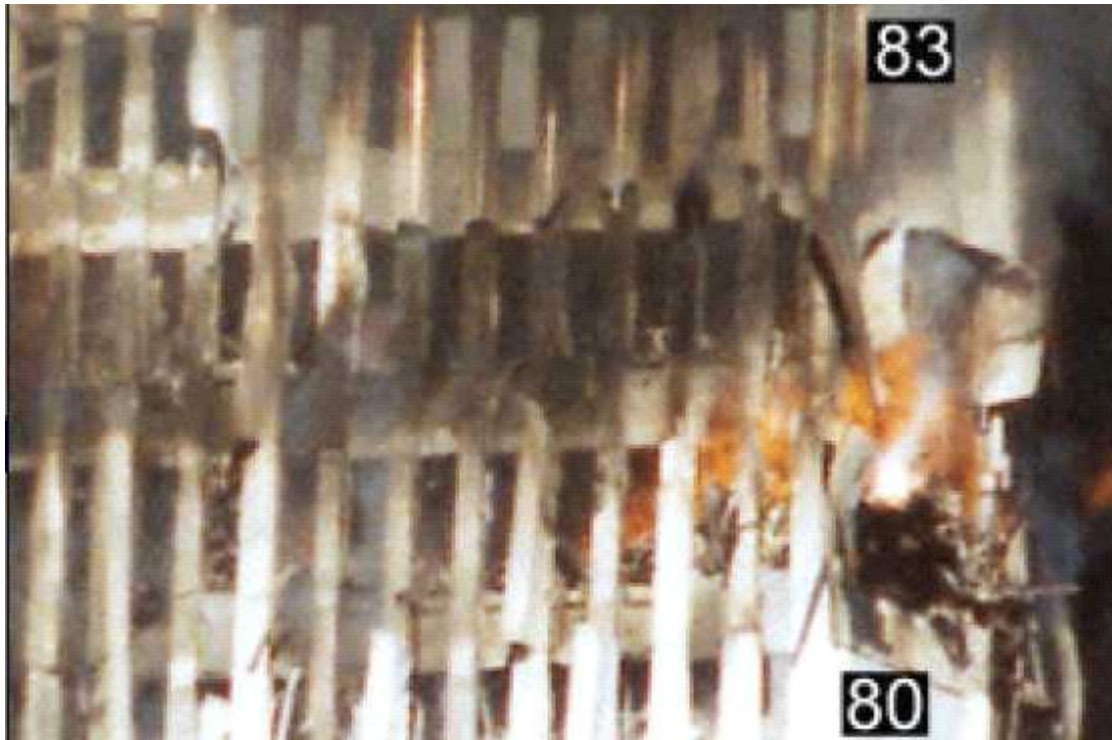
An intriguing photograph found as Figure 9-44 in the NIST report provides evidence for a highly exothermic reaction at the corner of the South Tower just minutes before its collapse. Furthermore, failure occurs at this very corner of the Tower as seen in this video footage: <http://video.google.com/videoplay?docid=-8564772103237441151&q=cameraplanet+9%2F11>.

“An **unusual flame** is visible within this fire. In the upper photograph {Fig 9-44} a **very bright flame, as opposed to the typical yellow or orange surrounding flames, which is generating a plume of white smoke, stands out.**” Source: NCSTAR 1-5A Chapter 9 Appendix C NIST Fig. 9-44. p. 344

“NIST reported (NCSTAR 1-5A) that just before 9:52 a.m., a **bright spot appeared** at the top of a window on the 80th floor of WTC 2, four windows removed from the east edge on the north face, **followed by the flow of a glowing liquid.** This flow lasted approximately four seconds before subsiding. **Many such liquid flows were observed from near this location in the seven minutes leading up to the collapse of this tower.**” Source:

Thus it is established that the "glowing liquid" flow is associated spatially and temporally with the "bright spot" observed on the corner of the 80th floor of WTC 2. The photograph below shows, for comparison, a thermite reaction with a white aluminum-oxide dust plume extending from very bright reaction region. (Experiment by the author and colleagues in which thermite-plus-sulfur cut through a steel cup in a fraction of a second. Any thermite reaction is a dangerous reaction and should only be performed by a trained professional capable of assessing the hazards and risks.) The similarities between the known thermite reaction and the hitherto unknown reaction at the WTC Tower are plain to see. These discoveries strongly motivate an immediate in-depth investigation of the use of thermite-type reactions in the destruction of the World Trade Center on 9/11/2001.

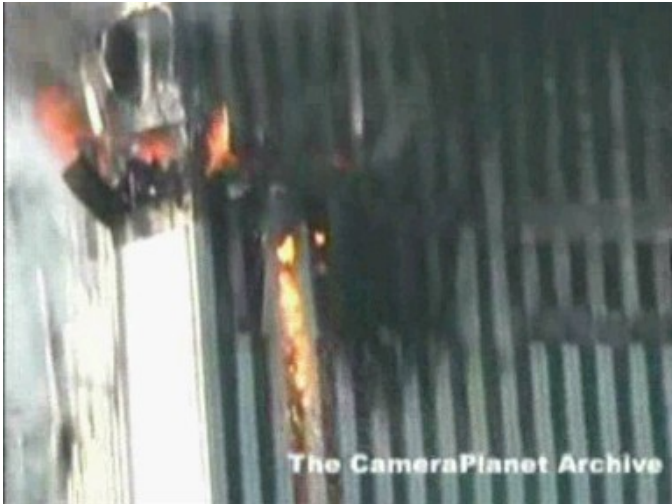
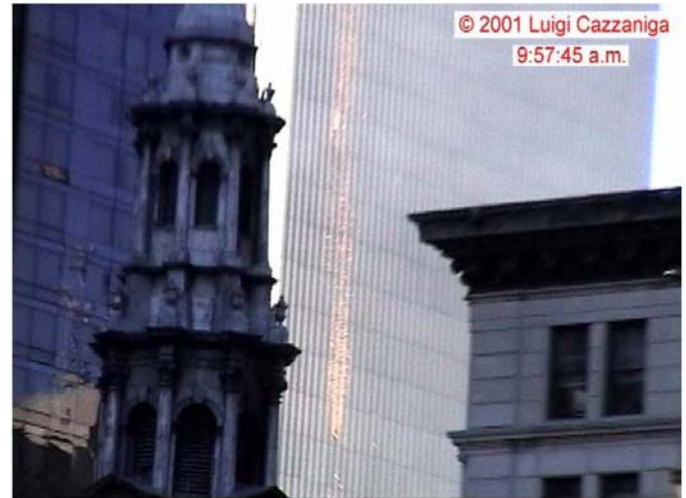
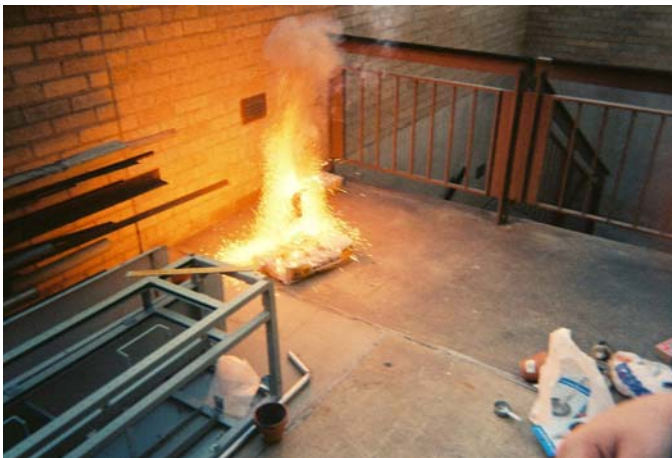
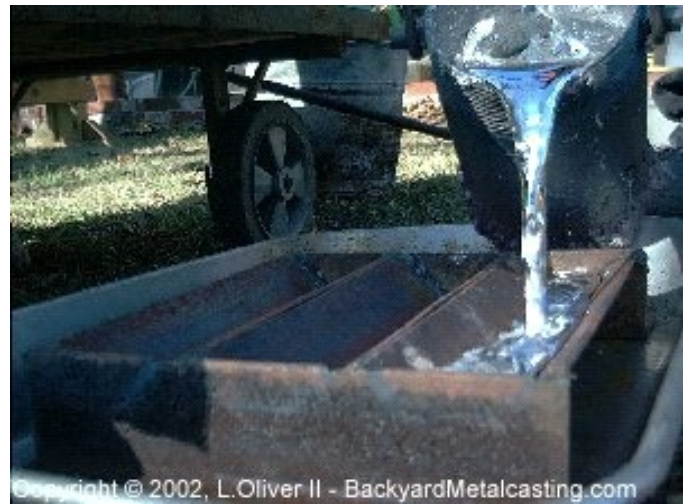
Dramatic footage reveals yellow-to-white hot molten metal dripping from the South WTC Tower at this SAME CORNER just minutes before its collapse:
<http://video.google.com/videoplay?docid=-2991254740145858863&q=cameraplanet+9%2F11>. I assert that this glowing liquid metal is consistent with flowing liquid iron from a nearby thermite reaction zone, the "bright spot" in the NIST photo. Other photographs capture the same significant event, clearly showing yellow-white hot liquid metal dripping from the South Tower, still hot as it nears the ground below.

Is the falling molten metal from WTC Tower 2 (Top photos) more likely molten iron from a thermite reaction (lower left) OR pouring molten aluminum (lower right)?

Who can deny that liquid, molten metal existed at the WTC disaster? The yellow color implies a molten-metal temperature of approximately 1000 °C, evidently above that which the dark-smoke hydrocarbon fires in the Towers could produce. If aluminum (e.g., from the plane) had melted, it would melt and flow away from the heat source at its melting point of about 650 °C and thus would not reach the yellow color observed for this molten metal. Thus, molten aluminum is already ruled out with high probability. But molten iron with the characteristics seen in this video is in fact consistent with a thermite-reaction attacking the steel columns in the Tower, thus weakening the building just prior to its collapse, since thermite produces molten iron at yellow-to-white hot temperatures. (As some of the molten metal hits the side of the building in the video clip above, the white-hot interior is evidently exposed as the metal "splashes".) Also, the fact that the liquid metal retains an orange hue as it nears the ground (right photograph) further rules out aluminum, and suggests a mid-flight thermite reaction (typical of thermite).

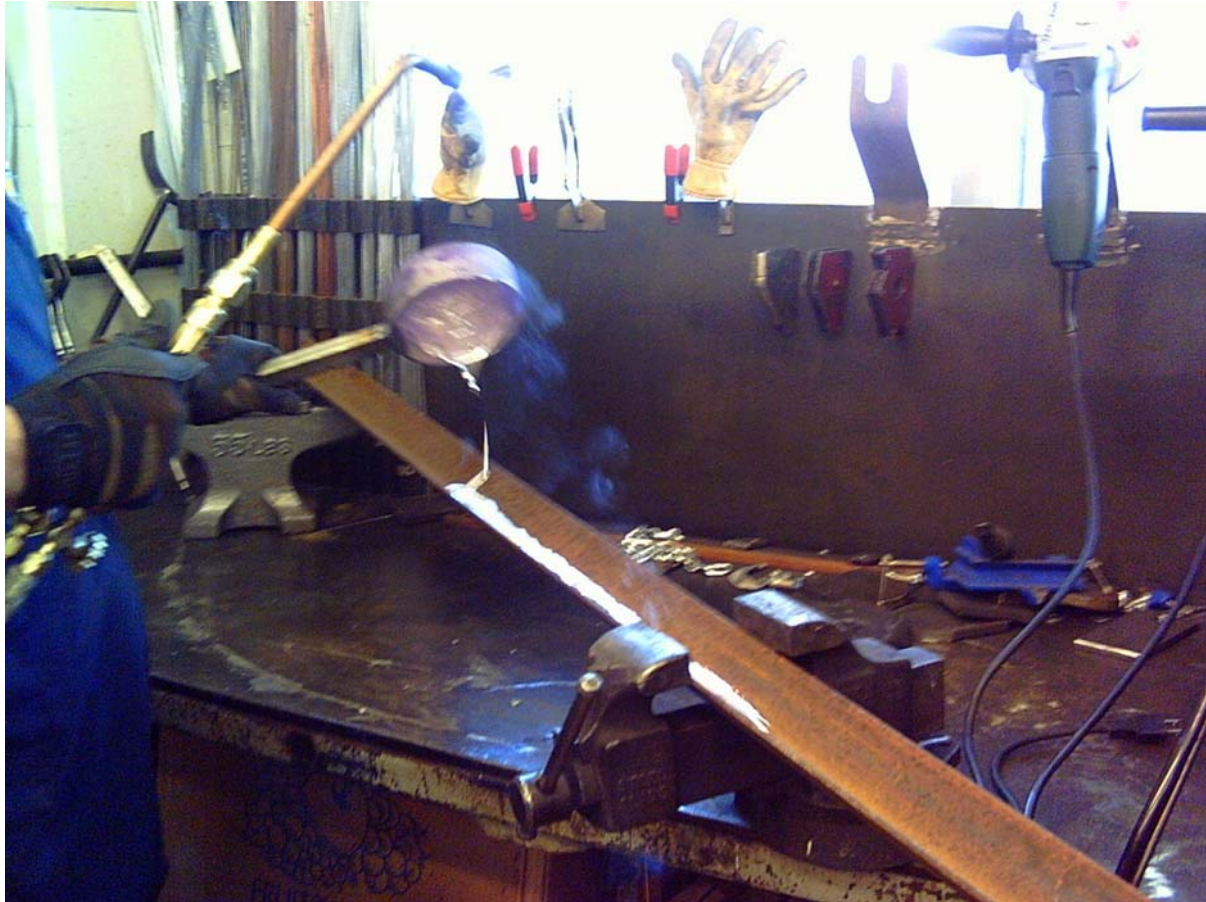
We also noted that while a steel pan holding the aluminum glowed red and then yellow hot, when poured out the falling aluminum displayed a silvery-gray color, adding significantly to the evidence that the yellow-white molten metal flowing out from the South Tower shortly before its collapse was NOT molten aluminum. (Recall also that the yellow color of the molten metal (video clip above) implies a temperature of approximately 1100°C -- too high for the dark-smoke hydrocarbon fires burning in the building.) This is a point worth emphasizing: aluminum has low emissivity and high reflectivity, so that in daylight conditions after falling through air 1-2 meters, molten aluminum will appear silvery-gray, while molten iron (with its characteristic high emissivity) will appear yellow-white (at ~1100°C) as observed in the molten metal dripping from the South Tower just before its collapse (see: <http://www.supportthetruth.com/jones.php>). We also recall that this molten metal, after falling approximately 150 meters (or yards) still retained a reddish orange color (photograph above). This is not the behavior of falling, molten aluminum.

Molten aluminum poured onto rusted steel: silvery flow, and no violent reactions observed at all.

NIST states the hypothesis that flowing aluminum with partially burned organic materials mixed in, "can display an orange glow." But will it really do this? I decided to do an experiment to find out. Our group melted aluminum in a steel pan using an oxy-acetylene torch. Then we added plastic shavings -- which immediately burned with a dark smoke, as the plastic floated on top of the hot molten aluminum. Next, we added wood chips (pine, oak and compressed fiber board chips) to the liquid aluminum. Again, we had fire and smoke, and again, the **hydrocarbons floated on top** as they burned. We poured out the aluminum and all three of us observed that it appeared silvery, not orange! We took photos and videos, so we will have the recorded evidence as these are processed. Of course, we saw a few burning embers, but this did not alter the silvery appearance of the flowing, falling aluminum.

We decided to repeat the experiment, with the same aluminum re-melted. This time when we added fresh wood chips to the hot molten aluminum, we poured the aluminum-wood concoction out while the fire was still burning. And as before, the wood floated on top of the liquid aluminum. While we could see embers of burning wood, we observed the bulk of the flowing aluminum to be silvery as always, as it falls through the air.

This is a key to understanding why the aluminum does not "glow orange" due to partially-burned organics "mixed" in (per NIST theory) - because they do NOT mix in! My colleague noted that it is like oil and water - organics and molten aluminum do not mix. The hydrocarbons float to the top, and there burn - and embers glow, yes, but just in spots. The organics clearly do NOT impart to the hot liquid aluminum an "orange glow" when it falls, when you actually do the experiment! Videos of our experiments involving organics added to liquid aluminum are available here: <http://www.scholarsfor911truth.org/Experiments-to-test-NIST-orange-glow-hypothesis.html>

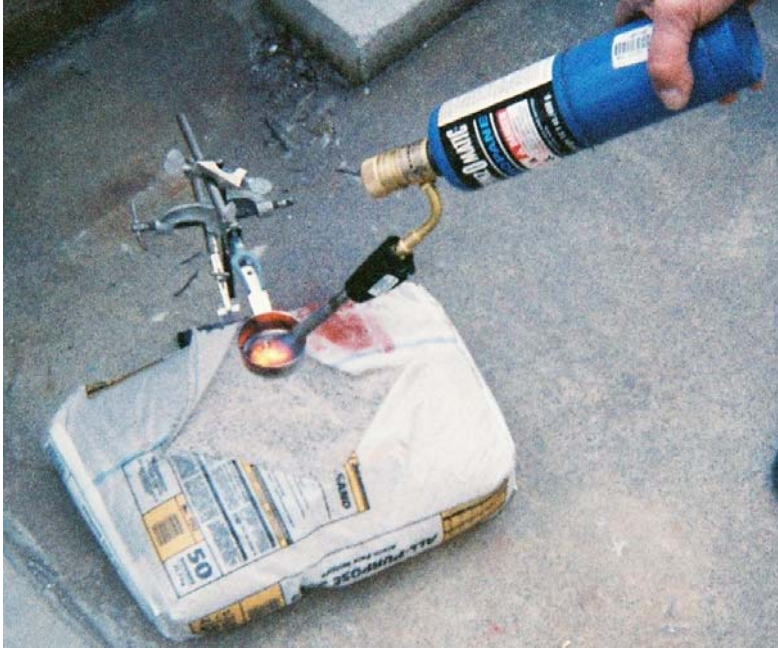
It is important to note that initiating the thermite reaction requires temperatures well above those achieved by burning jet fuel or office materials -- which is an advantage of using thermite charges over conventional monomolecular explosives such as TNT, RDX and PETN. Below is a photograph of an experiment performed by the author and colleagues at BYU in which a sample of thermite was heated to orange-hot temperature (about 1700 °F). We demonstrated that the thermite reaction would not ignite at this high temperature. Later, the thermite reaction was triggered by burning a magnesium strip in contact with the thermite. An electrical superthermite "match" could have been used and remotely triggered via radio signal.

Thermite did not ignite when heated with a propane torch.

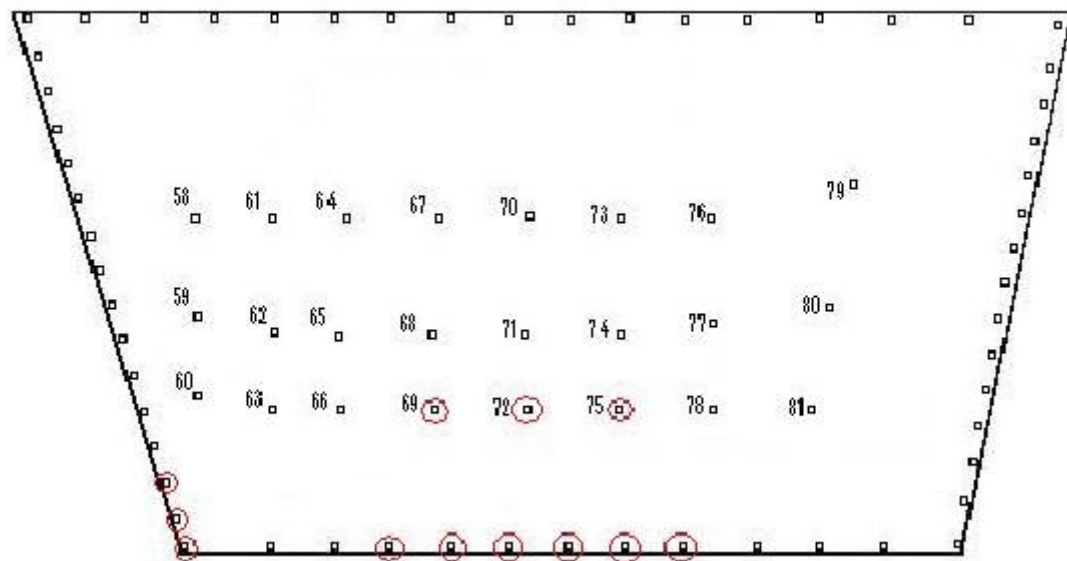
As you observed (link above), WTC 7 collapsed rapidly and nearly-straight-down symmetrically -- even though fires were randomly scattered in the building. WTC 7 fell about seven hours after the Towers collapsed, even though no major persistent fires were visible (considerable dark smoke was seen). There were twenty-four huge steel support columns inside WTC 7 as well as huge trusses, arranged non-symmetrically, along with some fifty-seven perimeter columns, as indicated in the diagram below (FEMA, 2002, chapter 5; NIST, 2005).

Diagram showing steel-column arrangement in WTC 7, view looking down on the roof. Circled columns were possibly damaged due to debris from WTC 1 collapse, some 350 feet away (NIST, 2005) so the damage was clearly non-symmetrical, and evidently, none of the core columns was severed by falling debris. WTC 7 was never hit by a plane.

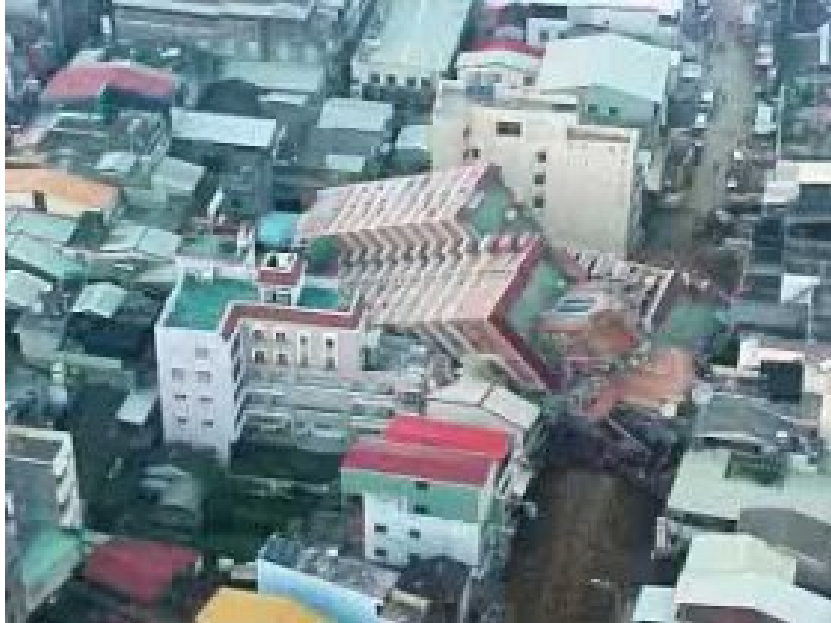
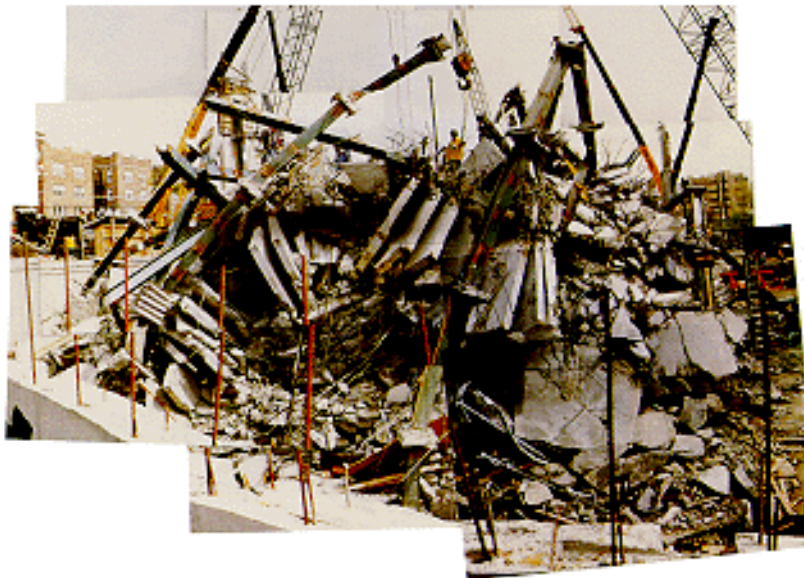
Non-symmetrical collapse of tall buildings when due to random causes. L'Ambiance Plaza collapse (right) shows how pancaked concrete floor slabs are largely intact and clearly reveal stacking effects with minimal fine dust, as expected from random progressive collapse. By contrast, concrete floors in the Twin Towers and WTC 7 were pulverized to dust -- as is common in controlled demolitions using explosives.

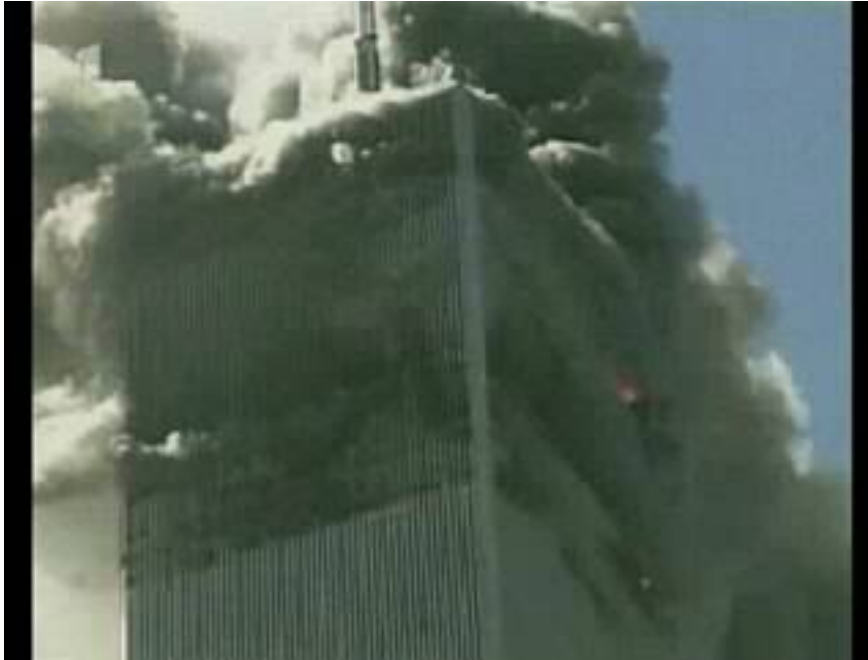
Review of videotape recordings of the collapse taken from various angles indicates that the transmission tower on top of the structure began to move downward and laterally slightly before movement was evident at the exterior wall. This suggests that **collapse began with one or more failures in the central core area of the building.** (FEMA, 2002, chapter 2; emphasis added.)

North Tower showing antenna (top) at beginning of collapse.

Yes, we can see for ourselves that the antenna drops first from videos of the North Tower collapse. (See http://911research.wtc7.net/wtc/evidence/videos/wtc1_close_frames.html; also <http://home.comcast.net/~skydrifter/collapse.htm>.) A NY Times article also notes this behavior:

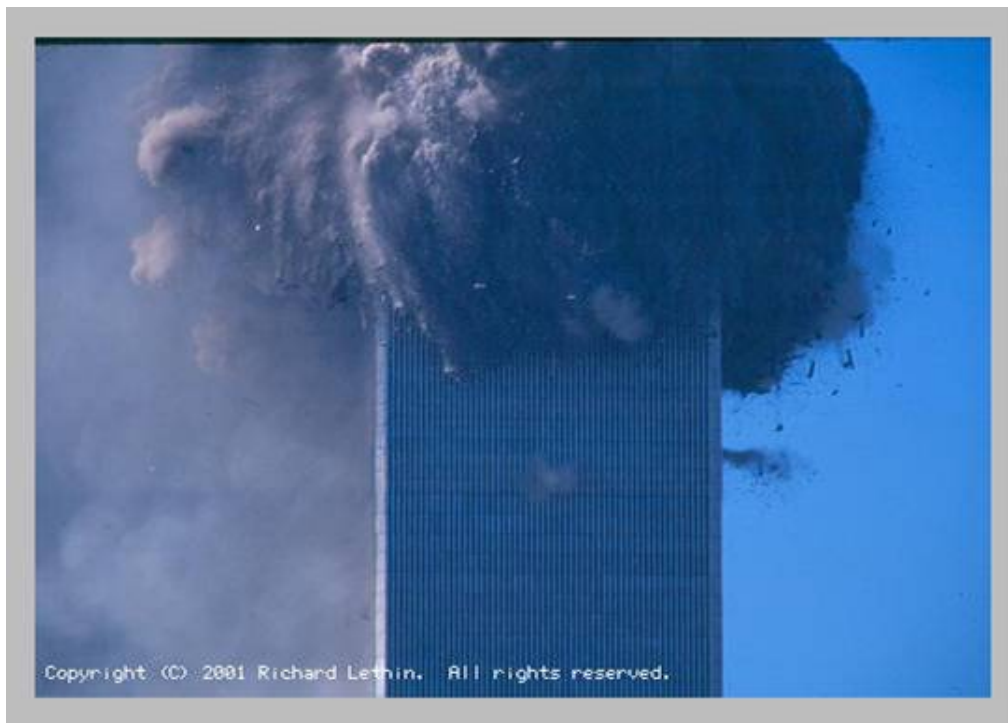
The horizontal ejection of structural steel members for hundreds of feet and the pulverization of concrete to flour-like powder, observed clearly in the collapses of the WTC towers, provide further evidence for the use of explosives – as well-explained in <http://911research.wtc7.net/talks/towers/index.html>. (See also, Griffin, 2004, chapter 2.) The observed plumes or "squibs" are far below the pulverization region and therefore deserving of particular attention. They appear much like the plumes observed in <http://www.implosionworld.com/cinema.htm> (e.g., the controlled demolition of the Southwark Towers).

North Tower during top-down collapse.
Notice mysterious horizontal plumes far below pulverization region.

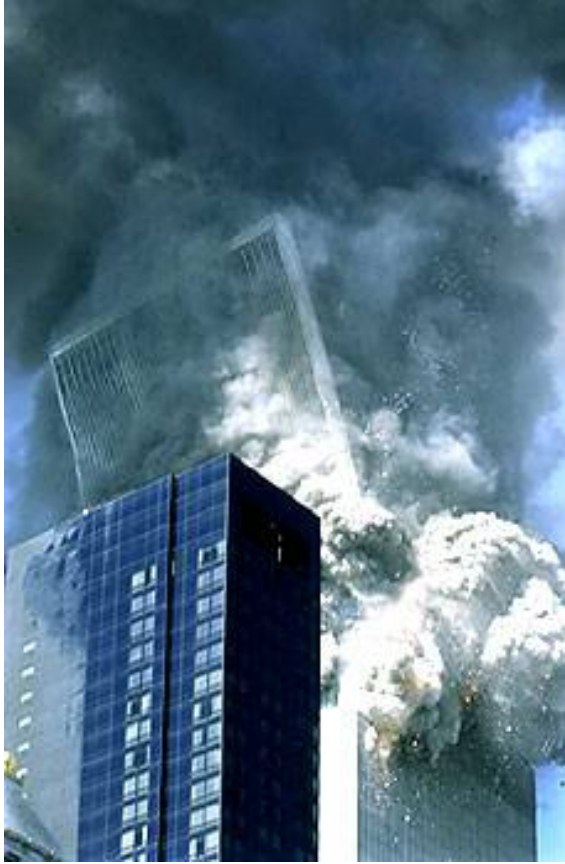
Top ~ 30 floors of South Tower topple over.
What happens to the block and its angular momentum?

We observe that approximately 30 upper floors begin to rotate as a block, to the south and east. They begin to topple over, not fall straight down. The torque due to gravity on this block is enormous, as is its angular momentum. But then – and this I’m still puzzling over – this block turned mostly to powder *in mid-air*! How can we understand this strange behavior, without explosives? Remarkable, amazing – and demanding scrutiny since the US government-funded reports failed to analyze this phenomenon. But, of course, the Final NIST 9-11 report “**does not actually include the structural behavior of the tower after the conditions for collapse initiation were reached.**” (NIST, 2005, p. 80, fn. 12; emphasis added.)

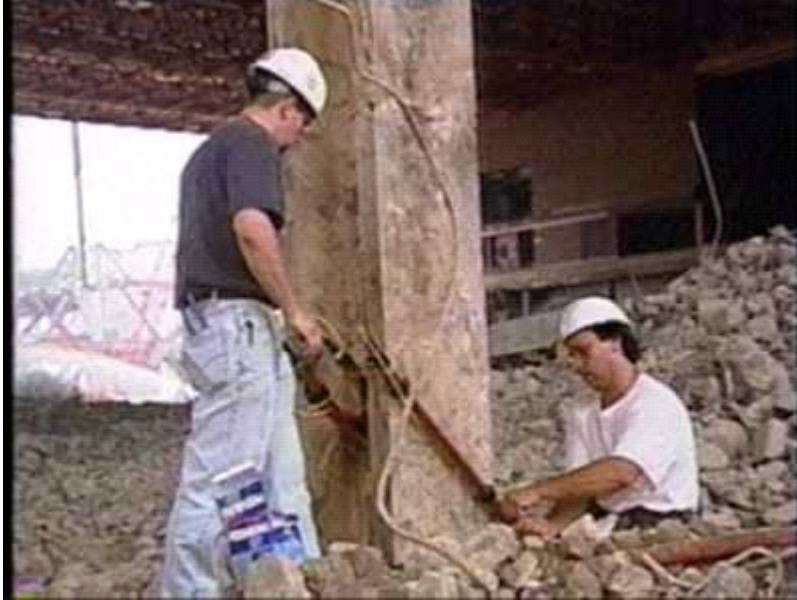
Above: two men install a conventional cutter charge to steel column, preparing for a controlled demolition of the building. Notice the narrow width/size of the explosive cutter charge. From History Channel: “Wrecking ball – Modern marvels” and thanks to Robert Moore and <http://piratenews.org/911con.html> .

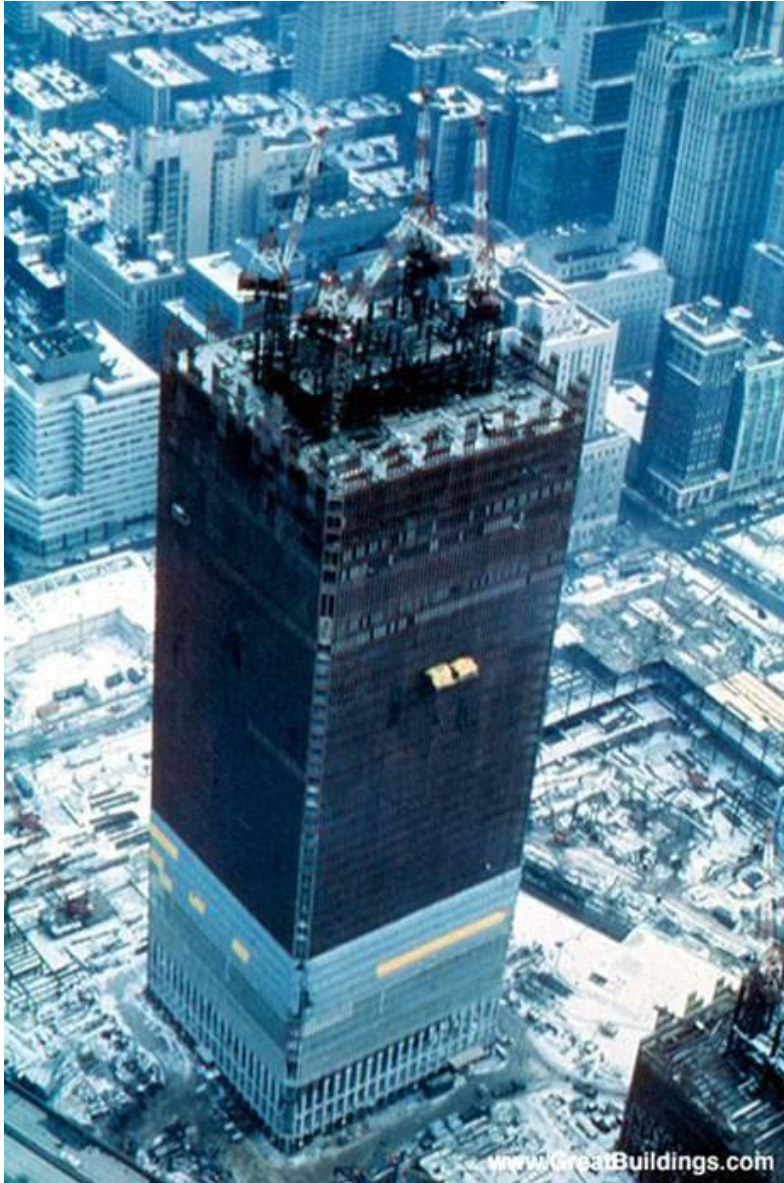
The WTC towers were solidly constructed with 47 steel core columns and 240 perimeter steel columns. 287 steel-columns total.

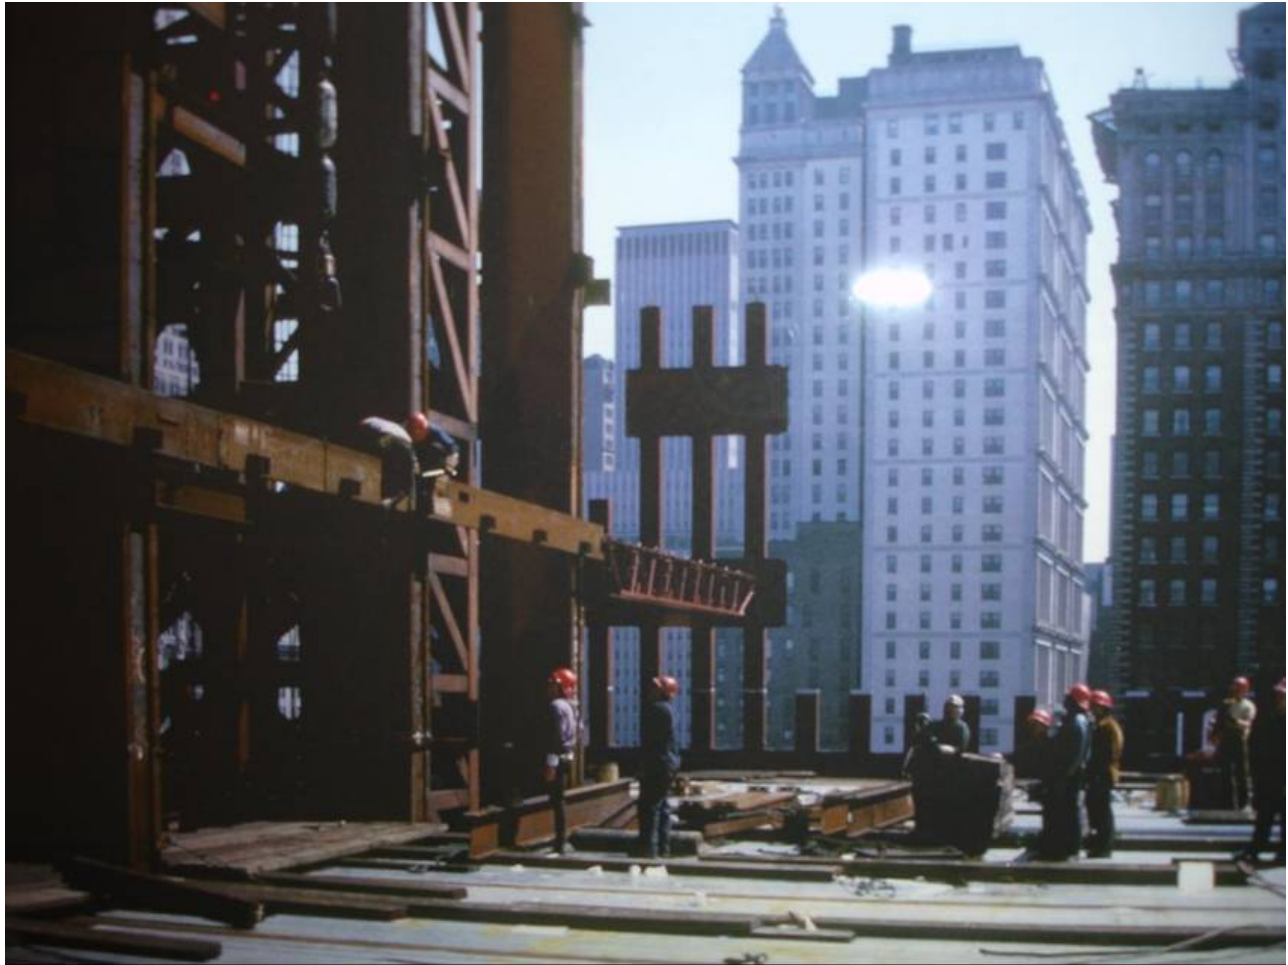
Steel-frame: Huge core (left) is an enormous heat sink. Notice workers standing on floor pan which is firmly attached to the interconnected core columns.
